Township of Oro-Medonte Communal Tile Field Performance Report 2023

Horseshoe Valley Municipal Communal Tile Field & Sewage Collection Systems Annual Report

Period Covering: January 1, 2023 to December 31, 2023

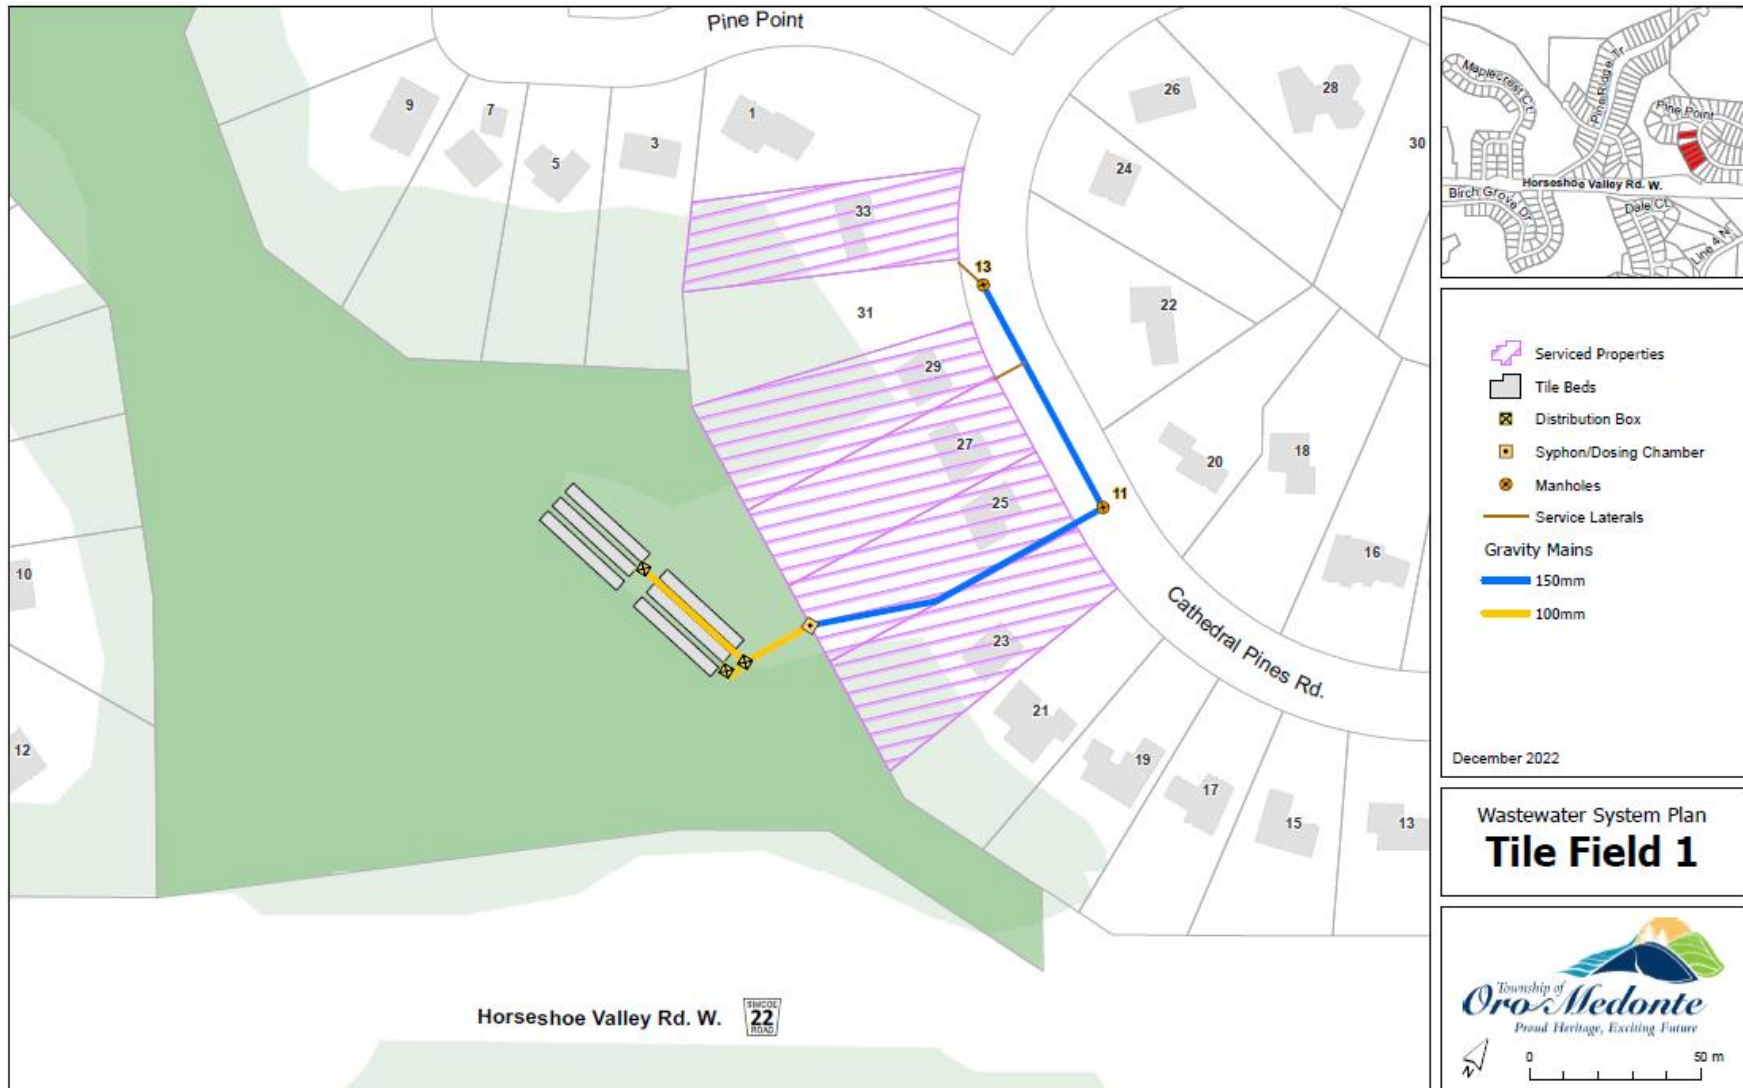
Wastewater System Plan Tile Field 1

Communal Tile Field 1 is located behind 23, 25, 27 & 29 Cathedral Pines Road. It services 5 properties (each equipped with an individual septic tank on their properties to serve as primary treatment). The effluent from the individual private septic tanks then flows through the municipal collection system to the communal tile field for subsurface

disposal through a syphon/dosing chamber and leaching bed. The collection system consists of 237 m of gravity sanitary sewer main and two manholes.

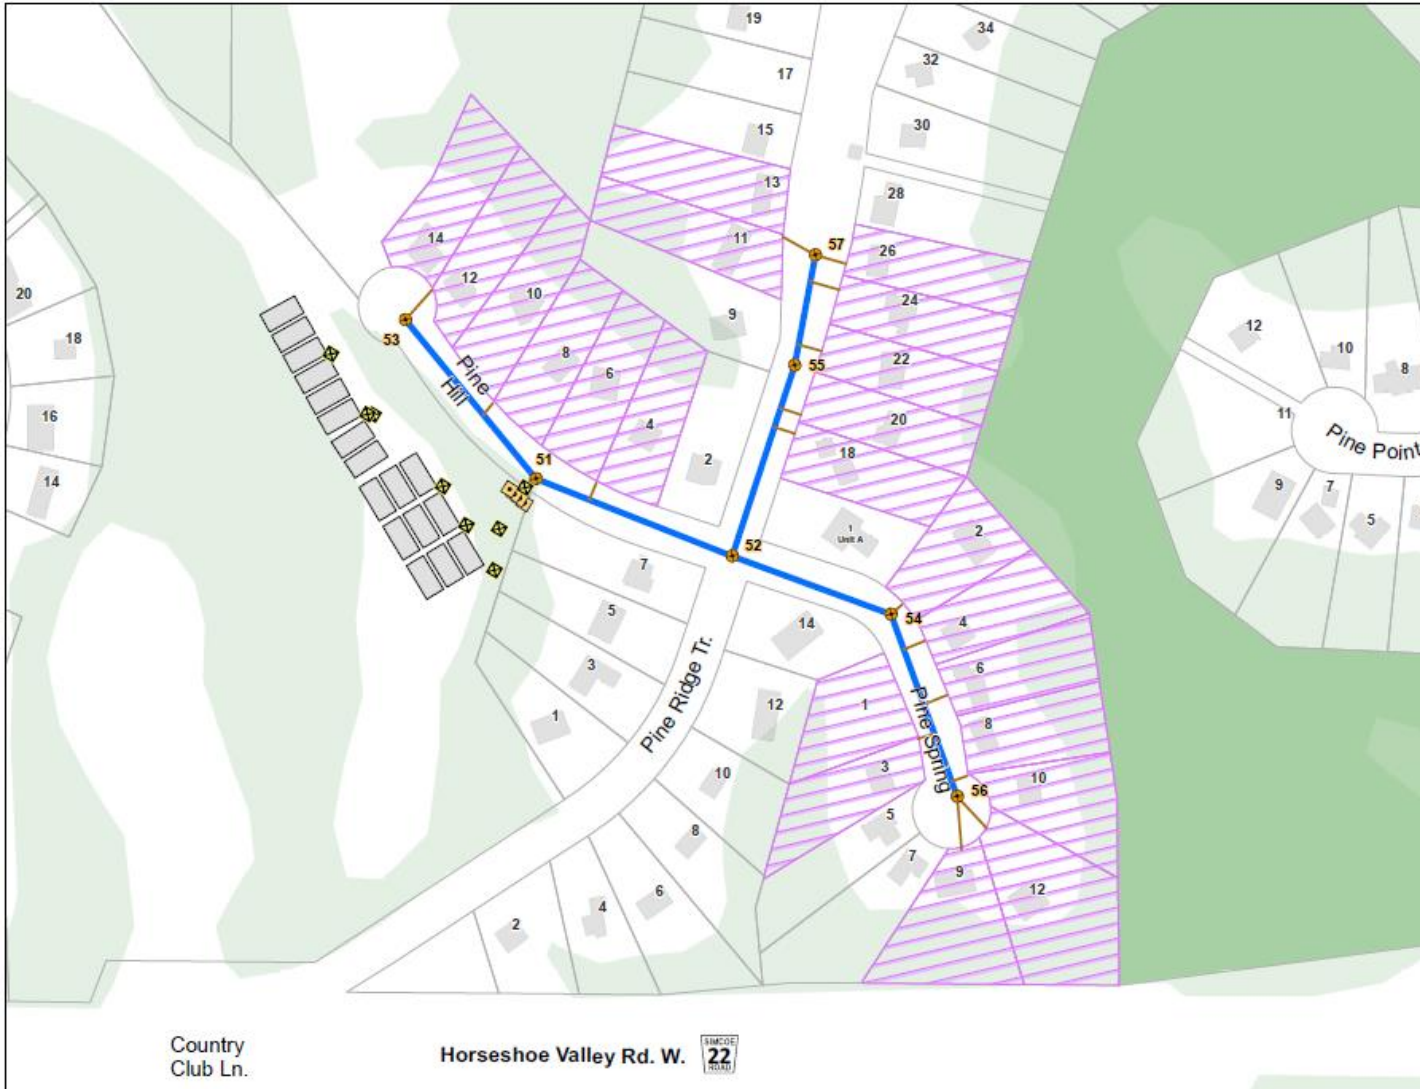
Wastewater System Plan Tile Field 5

Communal Tile Field 5 is located behind 1, 3, 5 & 7 Pine Ridge Trail. It services 22 properties (each equipped with an individual septic tank on their properties to serve as

primary treatment). The effluent from the individual private septic tanks then flows through the municipal collection system to the communal tile field for subsurface disposal through 4 syphon/dosing chambers and leaching bed. The collection system consists of 515.6m of gravity sanitary sewer main and 7 manholes.

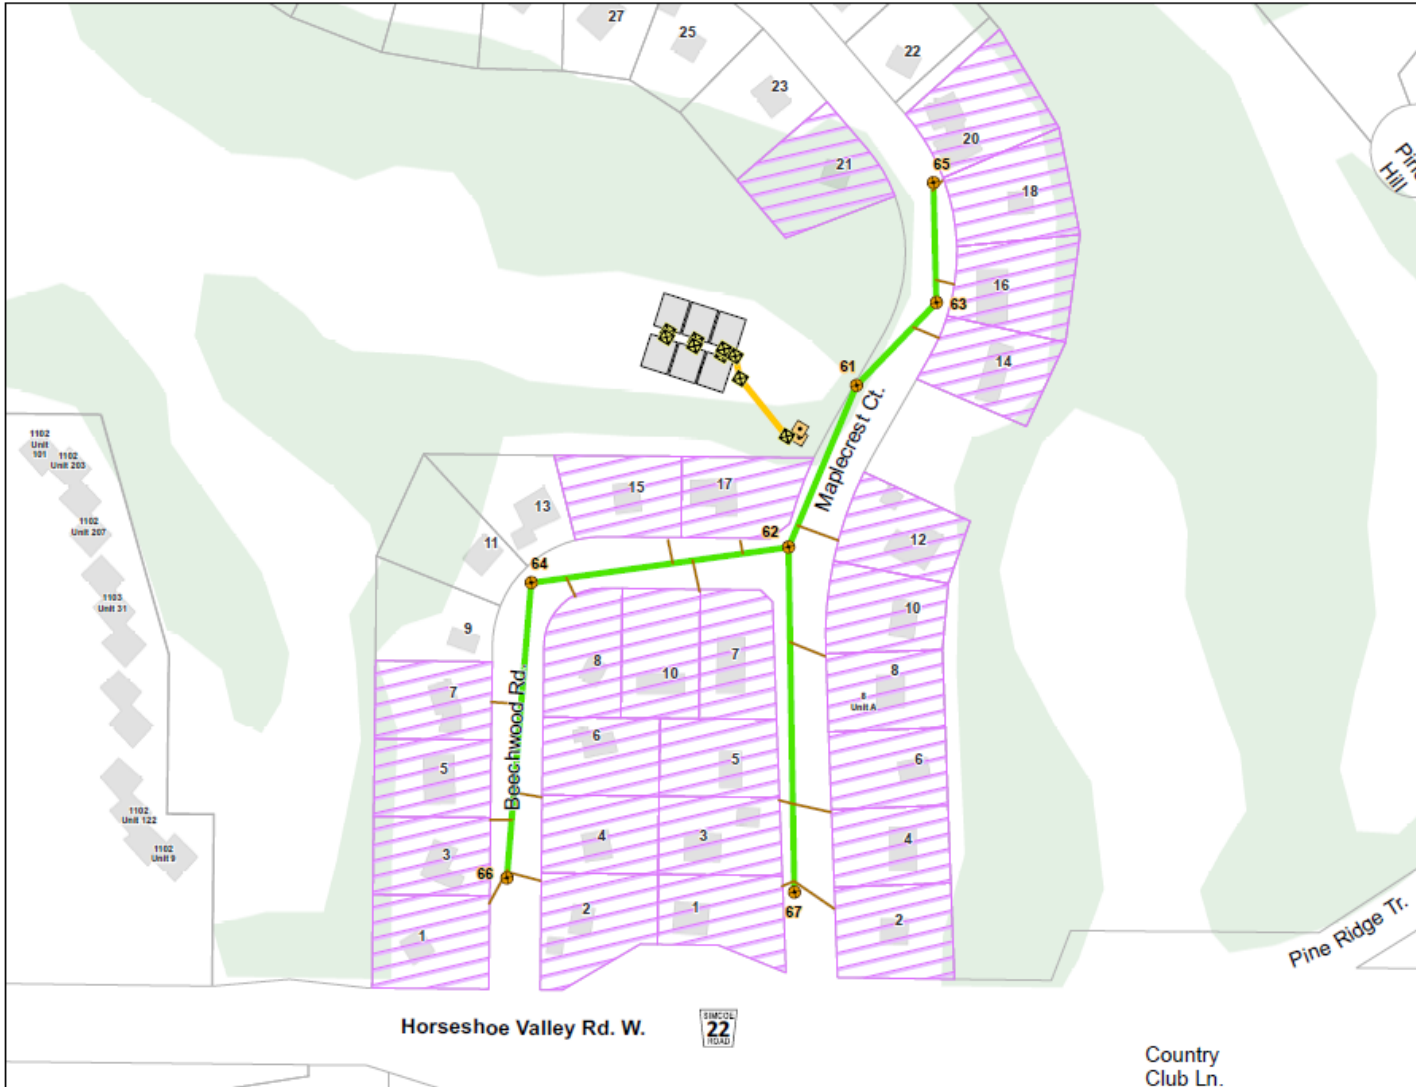
Wastewater System Plan Tile Field 6

Communal Tile Field 6 is located behind 15 & 17 Beechwood Road. It services 26 properties (.). The effluent from these properties flows directly through the municipal collection system to a communal septic tank, where the effluent then flows to a second septic tank for a two-staged treatment sequence. The effluent from the second septic tank then continues to the communal tile field for subsurface disposal through a leaching bed. The collection system consists of 559.6 m of gravity sanitary sewer main and 7 manholes.
